## **FAILURE ANALYSES OF A CORRODED PULSE GENERATOR**

E.W. Schuring  
M. Bregman

This investigation was performed by order of Sperry Sun Halliburton, Mr F. de Waal, Amperestraat 1G, 1976 BE IJmuiden, The Netherlands under ECN projectnumber 7.3330-01.

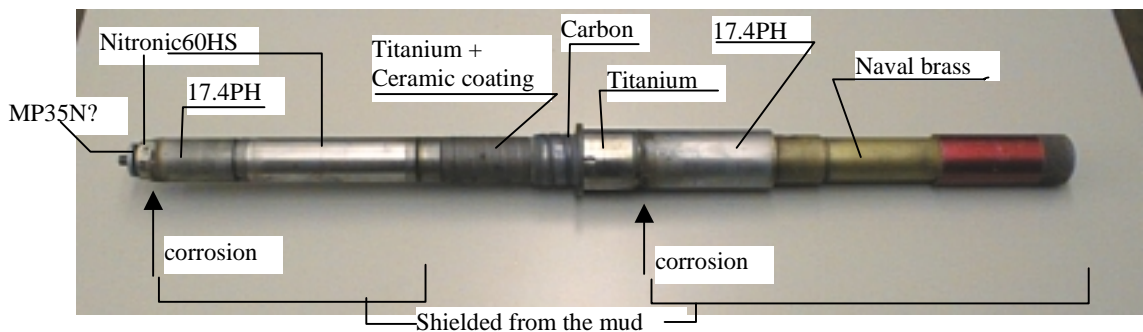
The corroded locations are indicated in Figure 2.1, while details are presented in Figure 2.2. During operation, the greater part of the corroded 17.4PH material is shielded from the environment by a nose cap and additional flow gear, see Figure 2.3. The submitted pulsar, serial number 1435, was operated for 97 below rotary hours and 60 circulation hours at an estimated temperature of 100°C. The pulse generator was operated during run 4 and 6 in well L5-B2.

Figure 2.1 Pulse generator in the as delivered condition, operated for 55h at 100°C. The different materials used and the corroded areas are indicated

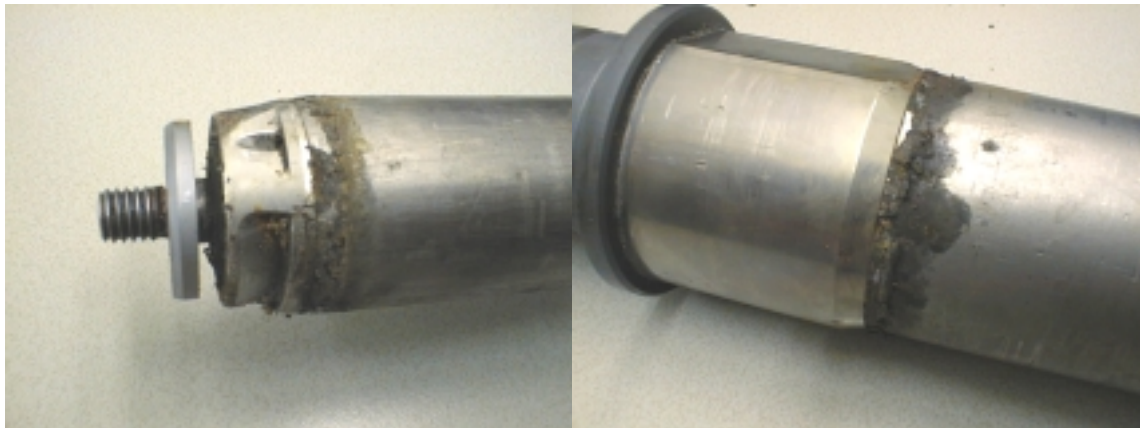
Figure 2.2 Details of the corroded 17.4PH parts

The corrosion products as shown in Figure 2.2, were analysed (see Table 3.1). The usual corrosion products were observed, being Fe-(Cr)oxides. The high amount of Cu can be explained by the naval brass components. Possibly small particles were embedded in the corrosion product.

The greater part of both corroded 17.4PH parts presented in Figure 2.2 are shielded by a nose cap and additional flow gear during operation. This implies that the surface area exposed to the mud of the material with the most negative or anodic corrosion potential, 17.4PH, is much smaller than that of the material with the more positive corrosion potential, Nitronic60SH which is more noble. As a result of this phenomenon, the corrosion current density at the 17.4PH material will increase and with that the corrosion rate.

- To prevent galvanic corrosion, 17.4PH is to be disconnected from the Nitronic60SH or to be replaced by this alloy or vice versa.
- Corrosion of the 17.4PH part of the magnet housing (2-inch case) is most likely caused by galvanic corrosion, since it is coupled to a noble Titanium part.

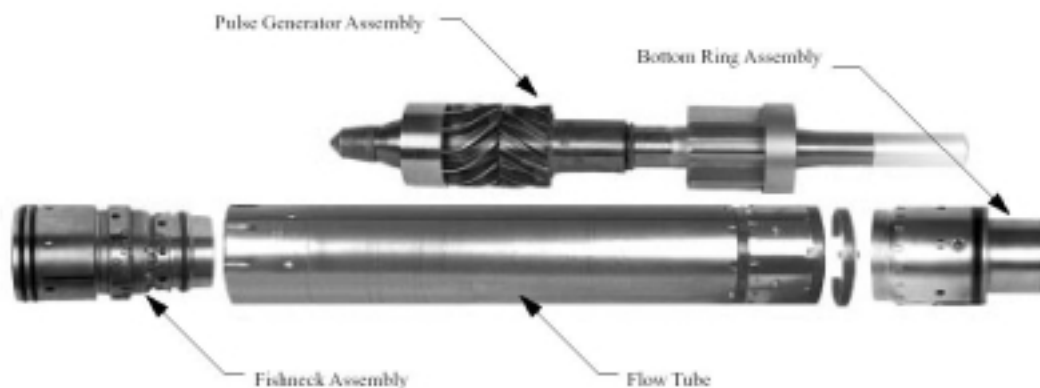
Figure 2.3 Pulse generator as it is used, complete with nose cape and additional flow gear

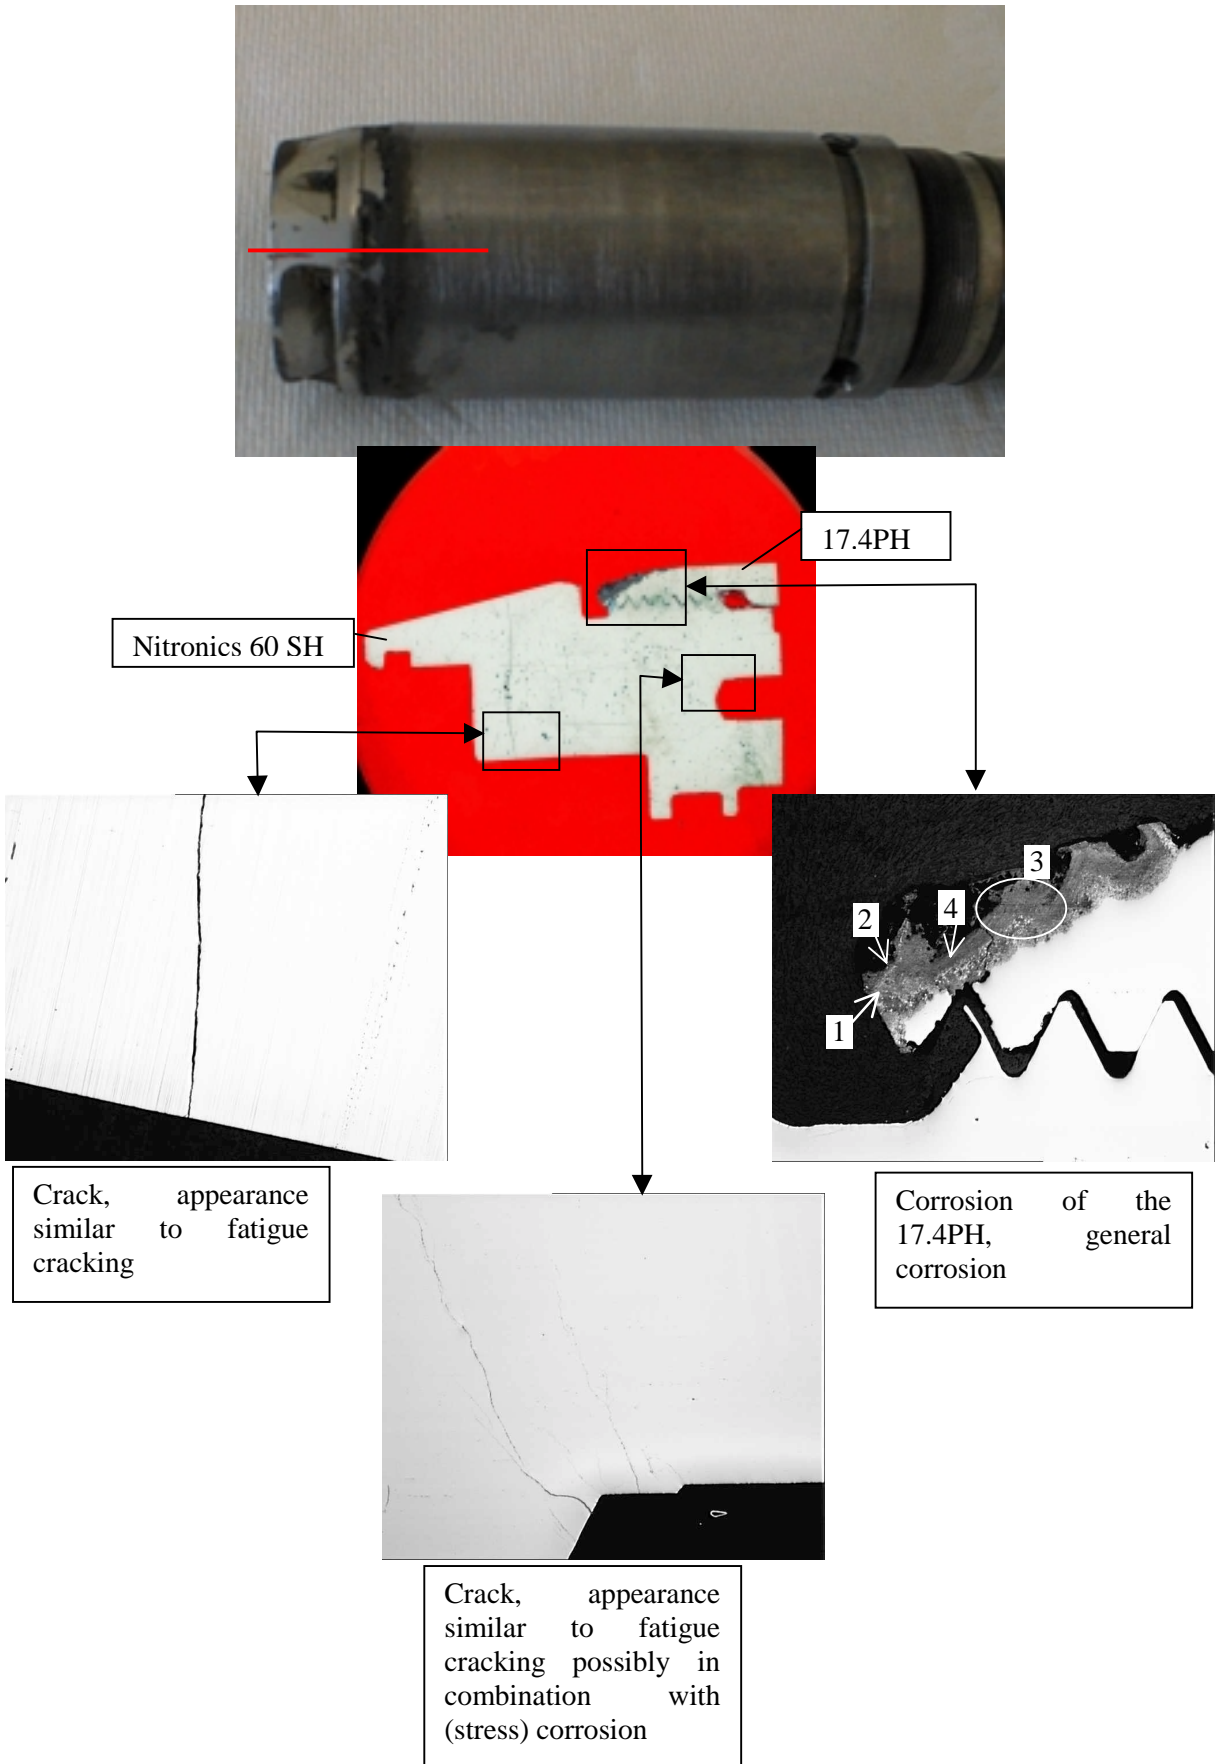
Details are presented in Figure 3.1. The metallographic investigation was limited to the Pulser Top End Assembly. For this investigation the Pulser Top End Assembly was removed from the outer pump case and the Cap Poppet Shact F/BP Top End was dismantled. All in accordance with document P01864 Rev A. A cross section was taken across the location as indicated in figure 3.1 and prepared using standard metallographic techniques. The cross-section shows the general corrosion in the 17.4PH material and several cracks in the Nitronic60SH material. These cracks appeared to be similar to fatigue cracking.

Figure 3.1 Overview of the head of the Pulse Generator #1435 and metallographic examination

The metallographic investigation revealed that the cracks in the Nitronic60SH material appeared to be similar to fatigue cracking or (stress)corrosion-fatigue. Together with the fact that a pulsed load will be applied to these parts during operation, it is reasonable to assume that the observed cracks in the Nitronic60SH material are most probably a result of fatigue cracking. Further investigation should be necessary to confirm this statement.

- The Nitronic60SH housing seal pack F/BP top end shows heavy cracking. The exact cause of cracking is still unknown, but appears to be related to fatigue or (stress) corrosion-fatigue.

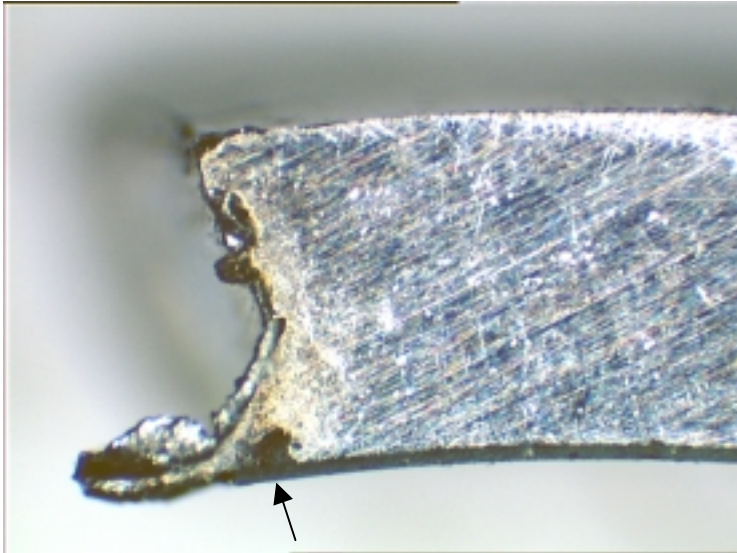
After the test, the material samples were visually examined. The 17.4PH sample showed a corrosion spot at the saw-cut of the sample, see figure 3.2. A cross-section was taken across this spot, see figure 3.3, and revealed slightly corrosive attack at this location, see figure 3.4.

Figure 3.2 *The 17.4PH sample subjected to the electrochemical cell. The corrosion spot at the saw-cut of the sample is indicated by an arrow*

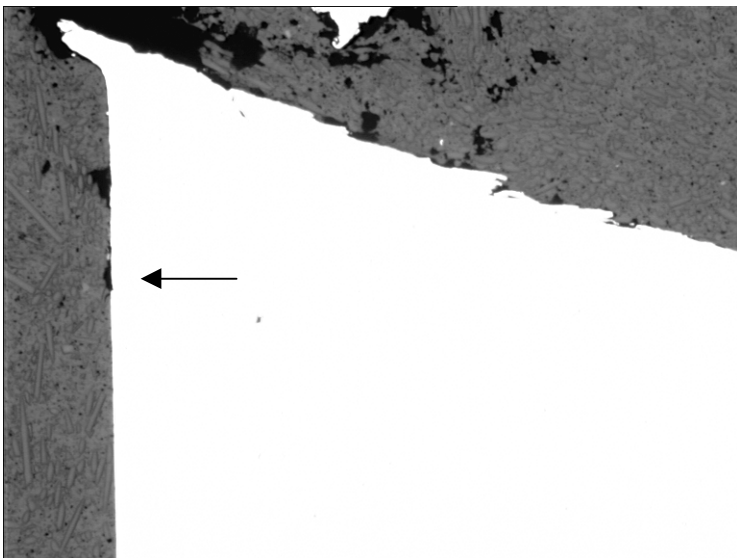
Figure 3.3 *Section across the corrosion spot of figure 3.2. Slightly corrosive attack can be observed*

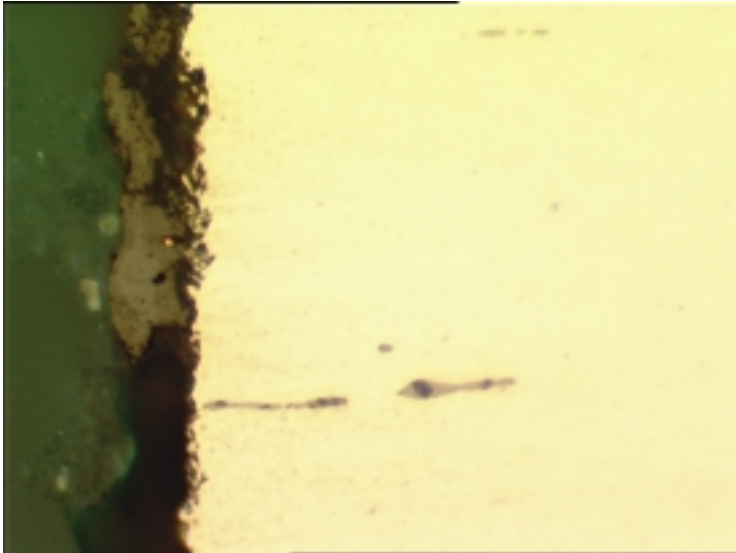
Figure 3.4 *Detail of figure 3.3 (indicated by the arrow), showing the corrosive attack at this location after 4 days of exposition at room temperature*
