geZONd

GEzamenlijke faciliteit voor ZONnepaneelanalyse en Duurzaamheidstesten

Contract ID: PiD-ZON 09-01

New test and characterization methods for PV modules and cells

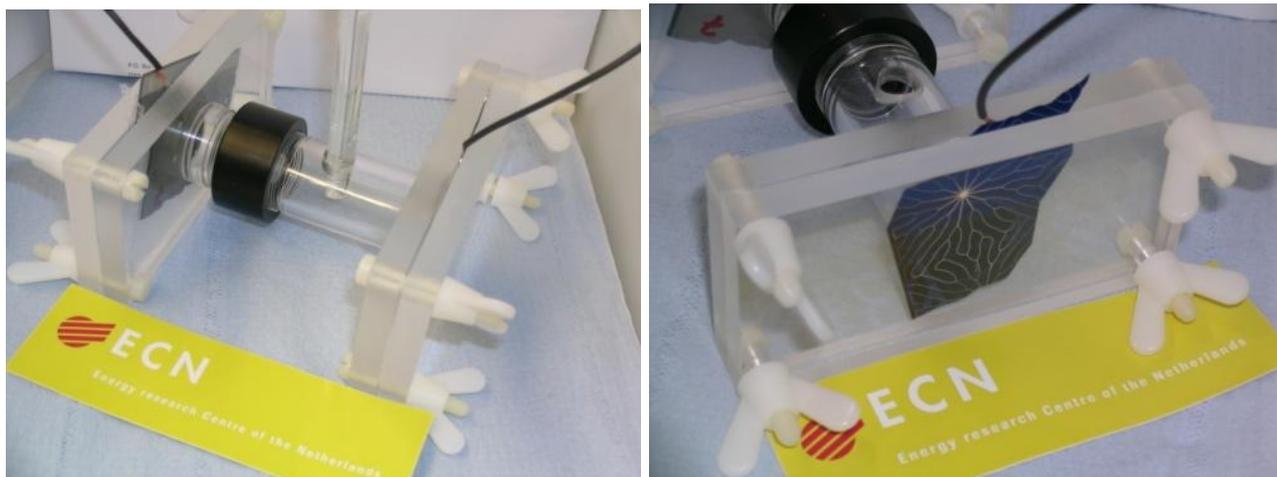
Figure 3.1: Photographs of the electrochemical noise set-up. In the centre of the electrolyte container, a reference electrode is placed. The right hand picture shows the piece of an MWT solar cell clamped between two polymer blocks.

The development team *Corrosion* has investigated new test and analysis methods for electrochemical reactions in the electrodes and interconnects, particularly the detection of corrosion in-situ in a climatic chamber, such that the process can be followed and failure rates can be determined. Multi-crystalline PV modules have been used as test objects. Electrical measurements (differential resistance) of special test structures inside the PV modules during the climate test have been implemented. An electrochemical noise (EcN) measurement has been developed to test corrosion rates much faster than typical climate chamber tests (see Figure 3.1). For analysis, electrochemical impedance spectroscopy (EIS) has been used, complemented with local chemical and morphological analysis, in particular (planar or cross-section) SEM-EDX.

We conclude that EcN is a very useful tool for corrosion prediction. Therefore, it is already applied within *ECN – Solar energy* as a predictive tool. We foresee possibilities for EcN in the solar industry, both for testing new batches of metal pastes and encapsulant in a production facility, and for pre-selecting new material combinations in an R&D environment. The EcN setup is sensitive to the lay-out of the tested samples and the microstructure of the materials involved. Choosing the right electrolyte allows fast testing (within a day). ECN is working on the valorisation of these results.

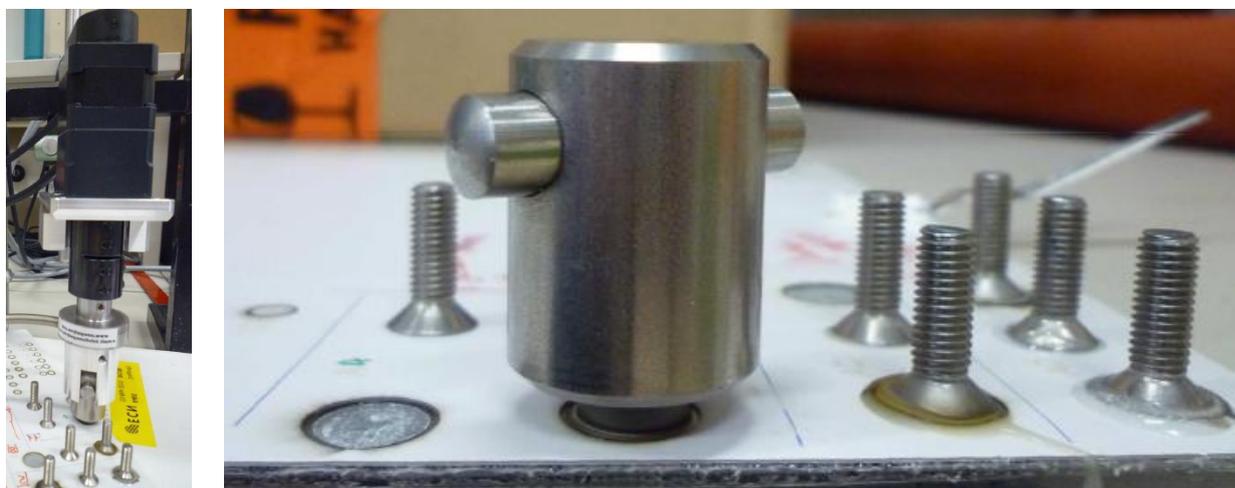
Figure 4.1: Left: overview image of the core/shear set-up. Right: detail of the torque-head.

Adhesion strength was tested using peel-testing and core-shear equipment built within this project (see Figure 4.1). For the present set of samples, peel strength measurements are difficult to interpret due to inherent limitations (elasticity, brittleness) of the foils. A complication of core-shear testing here is that samples often delaminate during (mechanical) coring, so that no quantitative shear measurement is possible. This was solved by developing a laser coring technique. We found that the adhesion strength of all laminates decreases with prolonged DH duration. Back contact modules often fail at one of the interfaces of the solder mask.

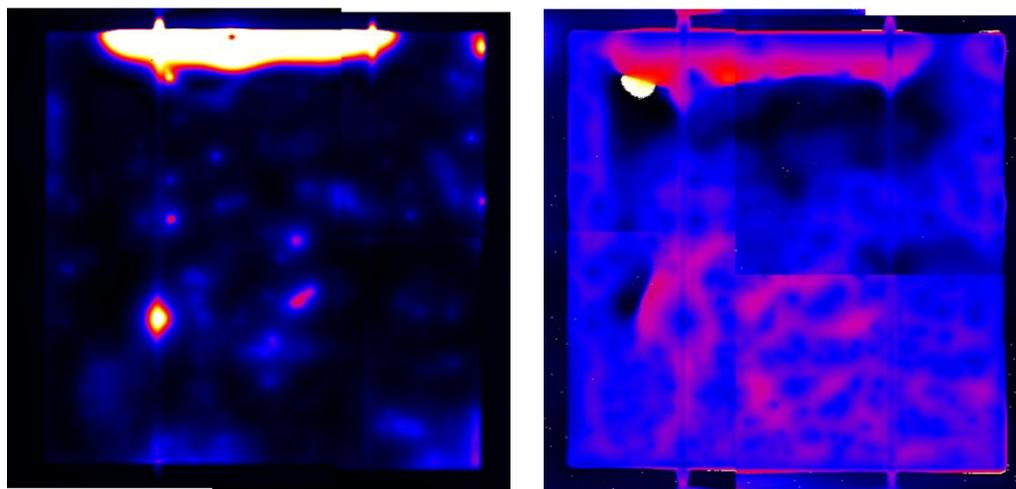
Figure 4.2: TM-LIT amplitude (left) and phase (right) images of cell A854, displaying delamination at one of the edges of the cell prior to DH testing. Because of this 0h failure, this cell was not used for further testing.

Delamination (e.g. of back-sheet foil, or around contact holes) can non-destructively be characterized using LIT, SAM and Moire imaging. We have developed a special thermally modulated LIT technique, which allows thermography also when electrical addressing of the cell/module is not desired or possible (see Figure 4.2). SAM not only enables visualization of delamination, but also displays chemical degradation at the interface, thereby providing indications for possible changes in adhesion strength prior to actual delamination.

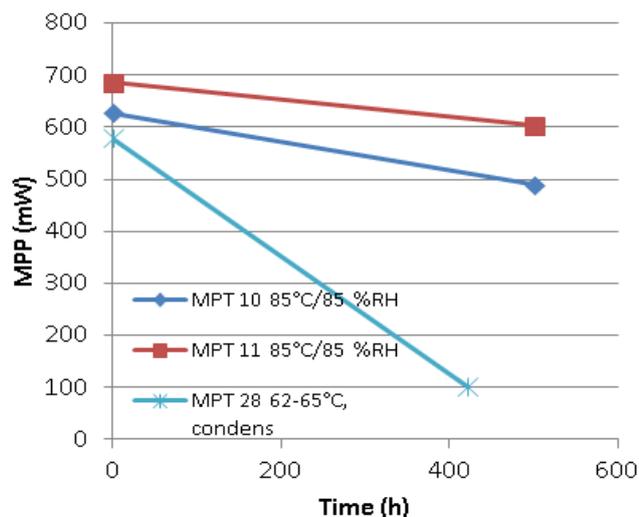
Figure 5.1: Change of power output for condensation conditions during 422 h at T= 62-65°C, RH=76-89% compared to a 500 h damp heat test (85°C/85% RH) for several shiny MPT6-150 samples.

Accelerated ingress of water into thin film PV modules has been achieved by means of moisture condensation on commercially available devices tested. Powerfilm and Konarka Power plastic have shown to be susceptible at various levels to increased moisture stress driven by condensation on the samples (see Figure 5.1 and Figure 5.2). Standard Powerfilm is very sensitive to condensation conditions, ultimately resulting in complete disintegration of the module. The “weather pro” Powerfilm, with more robust encapsulation, degrades much less. For Konarka power plastic a strong performance decrease is observed without any visual changes.

Condensation conditions obviously accelerate the ageing of the samples tested compared to just damp heat testing at the same temperature (investigated in a T range from 62-72 °C) but also compared to standard damp heat testing at higher temperature (85 °C)! Generally spoken this makes ageing under condensation conditions a very suitable method to assess susceptibility of PV modules towards moisture ingress in a short period of testing. Specifically for the type of thin film modules tested it is important that this is also feasible without temperature overstressing, which is inherent to standard damp heat testing for this type of modules.

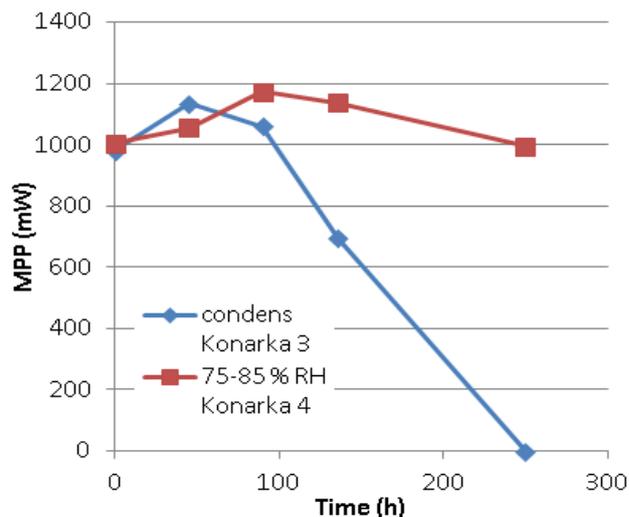
Figure 5.2: Change of power output for humid and condensation conditions compared for two Konarka samples during 250 h at T= 68-72°C/ RH=75-85 %.

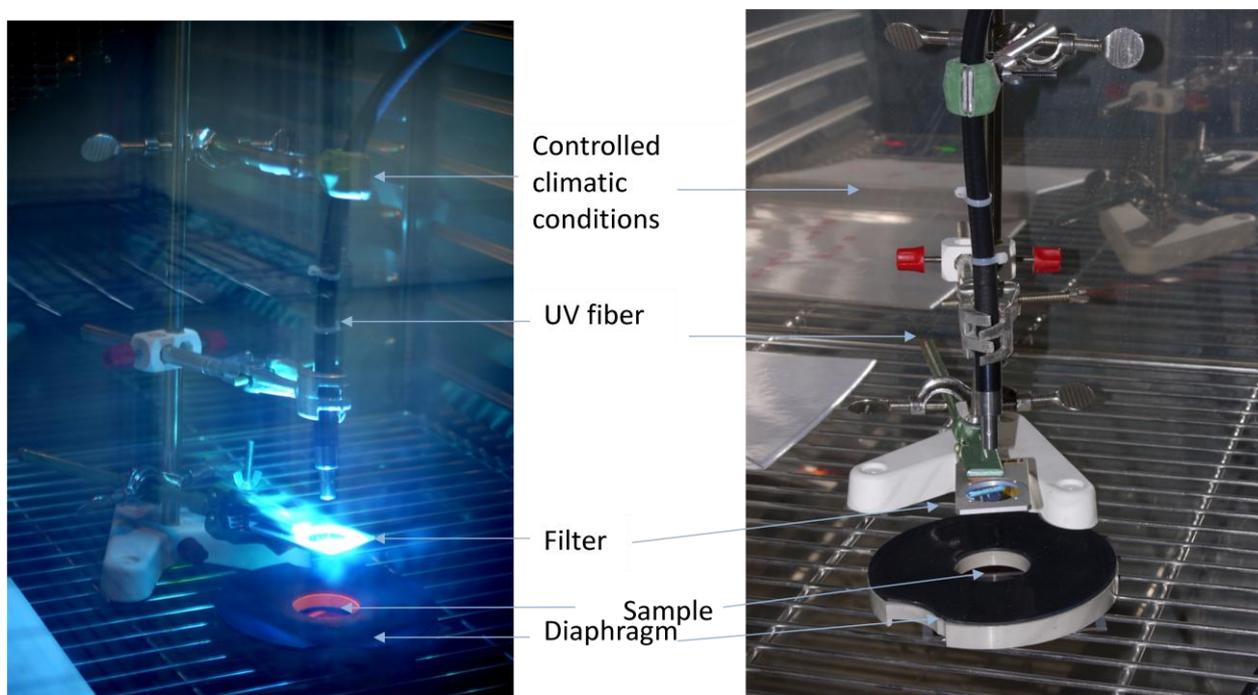
Figure 6.1: The 80-suns fast UV (FUV) set-up at OM&T.

We have built a special set-up for highly accelerated UV exposure while controlling the sample surface temperature inside a climate chamber (see Figure 6.1). We compared results with standard 1-sun UV exposure and tried to determine the acceleration factor. Samples used for the tests were encapsulant films on glass and polymer foils with or without SiN barrier. For characterization of the material changes, we use the following optical methods: (i) UV-Vis: Wavelength Resolved Optical Transmission through the sample, (ii) FTIR: Attenuated Total Reflection (Single Bound) in the Infra Red, and (iii) Raman Spectroscopy. For FTIR and Raman, the intensity of the background radiation is used as an indication for the deterioration.

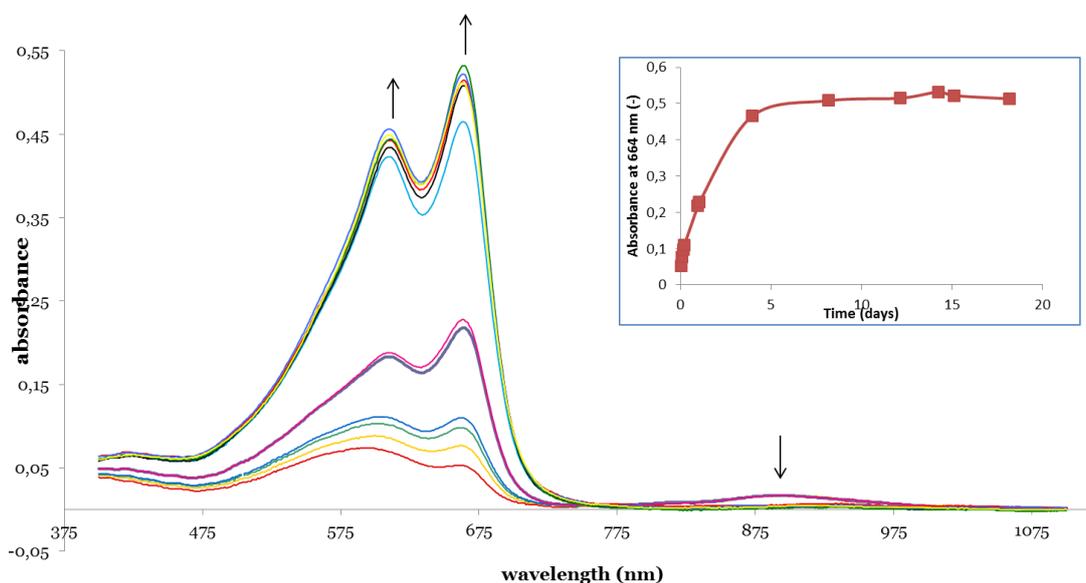
Figure 7.1: Example of the evolution of the spectrum of a coating in function of time for a 5- μ m-thick film left in air at room temperature.

The second strategy, which relies on the color change of a dye triggered by oxygen, displayed very promising results. A system based on methylene blue embedded in a polymer matrix was found to be a suitable oxygen sensor. This oxygen sensor could be easily solution processed in a reproducible way. The coating color change which is triggered by the reaction of the dye with oxygen was monitored by UV-Vis spectroscopy (see Figure 7.1). The color change speed can be increased by several ways, notably by increasing the temperature and/or by reducing the thickness of the coating (by e.g. using ink jet printing as processing method).
