# Outdoor degradation of CdTe modules at open circuit and at maximum power point

K. Sinapis<sup>1</sup>, G. Papageorgiou<sup>2</sup>, K. Durose<sup>2</sup>, M. van den Donker<sup>1</sup>, W. Folkerts<sup>1</sup>

<sup>1</sup>Solar Energy Application Centre, Eindhoven, The Netherlands

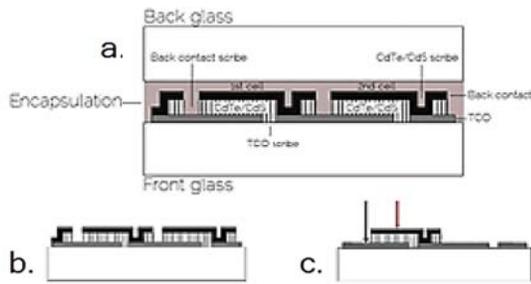
Fig. 1. Typical CdTe/CdS module: a) the configuration, b) with backside glass and encapsulation removed and, c) etched and contacted for laboratory investigations.

Finally, several small area samples from the degraded modules were prepared for further laboratory measurements. The small area samples were obtained by cutting the modules using a diamond wheel into 25 mm × 25 mm samples. These samples were annealed for short time periods using a hot plate at around 100°C so as to remove the backside glass and uncover the back contacts. Subsequently, 5 × 5mm<sup>2</sup> “active” regions were defined and the rest of the CdTe and CdS film was scraped off and etched with diluted HCl respectively. The study employed two groups of small area samples:

- DX.X - Samples extracted from the degraded modules, from a degraded region as judged by EL imaging.
  - RX.X Reference samples from a non-degraded module
- $EQE$ ,  $C$ - $V$  and  $J$ - $V$  measurements were conducted on these small area samples.

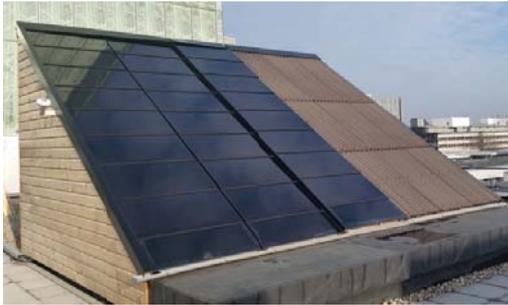
Fig. 2. The modules on the left hand side operate under MPP and were connected to micro inverters and power meter ('AC test') while the central and right hand modules were connected to an IV tracer ('DC test').

For this work, an outdoor building integrated PV field test has been set up in Eindhoven, The Netherlands. 24 commercially available CdTe modules were used for the field test. 16 of the 24 modules were used in the ‘DC test’. These modules were held at open circuit and tested with  $I$ - $V$  tracing equipment (EKO instruments MP-160) acquiring a full  $I$ - $V$  curve of 256 points every minute. 8 of the 24 modules were used in the ‘AC test’. These modules were connected to two micro inverters from Power One (MICRO 0.3HV). The energy output of the AC system was monitored through a kWh meter from UPP Energy. The module temperatures were monitored by type T thermocouples. Irradiance was measured with a secondary standard pyranometer (EKO instruments MS-802). Data was logged and saved every minute for all inputs simultaneously.

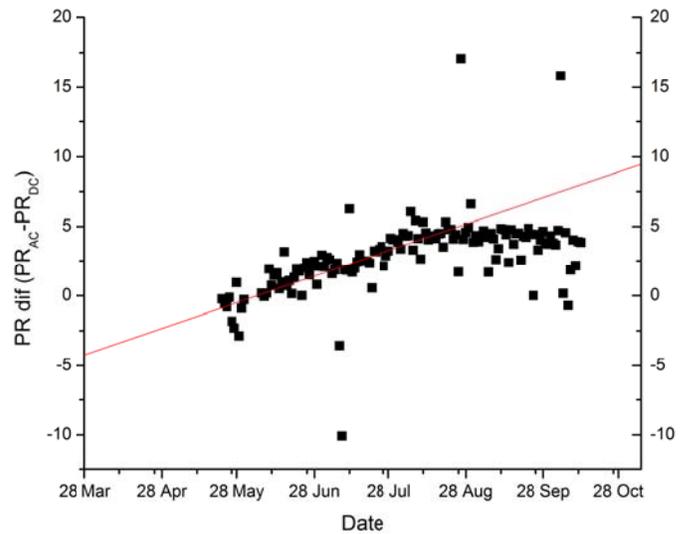
Fig. 3. Performance ratio difference of the AC (MPP modules) and DC ( $V_{oc}$  modules) vs field test date.

In fig. 3 the difference of the  $PR_{AC}$  and  $PR_{DC}$  is shown as a function of time during the trial. Unfortunately, the monitoring of the AC system started at a later stage than the DC system and for this reason the difference has been fitted and extrapolated back in time to estimate the PR differences starting from the 28th March when both the systems were installed. The initial difference of almost -5% is as expected taking into account the inverter and cabling losses of the AC system. By the end of May almost 5% of power degradation can already be observed for the open circuit modules of the DC system. The difference seems to stabilize around mid-August and continue almost unchanged until the end of field exposure.

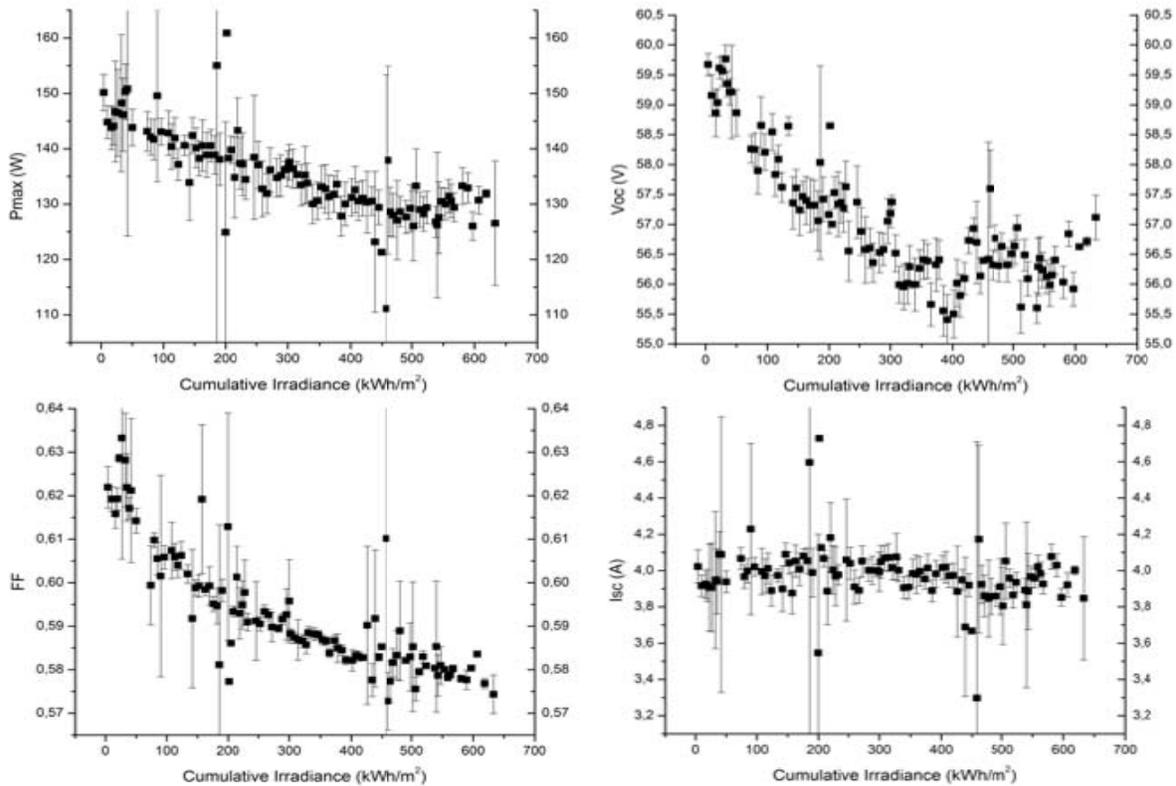
Fig. 4. Changes in the measured values from the CdTe modules in the ‘DC-test’ as a function of cumulative irradiance

The performance degradation was further investigated by analyzing the I-V data from the DC field test which was operated in open circuit. Data with plane of array irradiance close to STC conditions was filtered ( $990-1010 \text{ W/m}^2$ ) and corrected for  $25^\circ\text{C}$  reference temperature with coefficients provided by the manufacturer's spec sheet. From fig. 4 an average 12% degradation of  $P_{MPP}$  can be seen from the beginning of outdoor exposure on March until end of October 2014. The degradation of  $P_{MPP}$  can be primarily attributed to the degradation of  $V_{oc}$  and  $FF$  (6 and 7% respectively).  $P_{MPP}$  degradation seems to stabilize after approximately  $450 \text{ kWh/m}^2$  of irradiance. It is important to mention that the degradation of the three primary parameters ( $V_{oc}$ ,  $FF$  and  $P_{MPP}$ ) of the solar module started immediately after outdoor

exposure while  $I_{sc}$  data shows small variations from month to month due to the irradiance sensitivity of  $I_{sc}$ . A very small degradation of  $I_{sc}$  of less than 2% can be observed for the whole period of outdoor exposure which falls in the measurement uncertainty of the equipment and no clear correlation can be made. Similar results are supported by previous work [7].

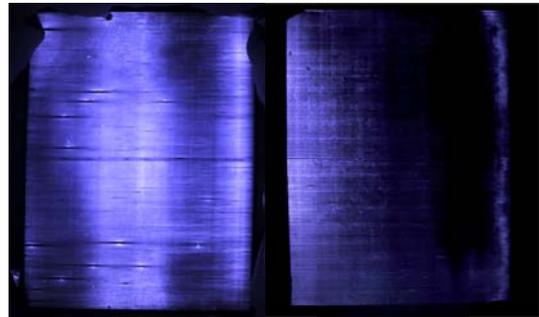
Fig. 5. Electroluminescence pictures from a non-degraded (left) and a degraded (right) degraded CdTe solar module.

To gain more insight into the observed degradation between the modules operating in open circuit and MPP, electroluminescence imaging was utilized. In fig. 5 an EL image of a non-degraded reference and a degraded module from the DC field test are shown. In the non-degraded module local shunts and scribing failures can be seen while at the degraded module (Fig. 5-right) a large area of the module’s surface seems severely affected. As described in literature [8], damage to the TCO layer interrupts current flow and causes dark regions in the EL image. Similar results were observed for all the modules operating at  $V_{oc}$ . Therefore, TCO damage is proposed as a degradation mechanism.

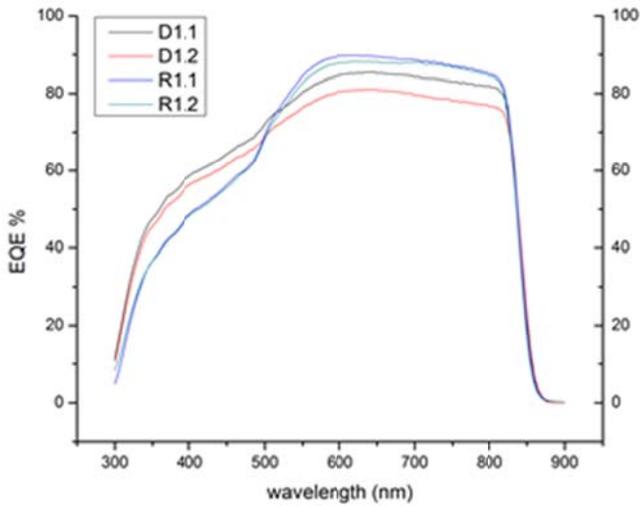
Fig. 4. *EQE* measurements from cells of the degraded outdoor exposed modules (D1.1, D1.2) and from the reference module that was stored in the dark (R1.1, R1.2).

Fig. 6 shows representative  $EQE$  measurements from the degraded (D1.1, D1.2) and reference (R1.1, R1.2) samples. In order to evaluate these results, the main features of a typical  $EQE$  of a CdTe/CdS solar cell are analysed, these being:

- Region 1 (<500 nm): CdS and high resistivity transparent (HRT) layers
- Region 2 (500-550 nm): CdS/CdTe intermixing
- Region 3 (550-850 nm): CdTe

Comparison of the D1.X and R1.X  $EQE$ s shows an average efficiency gain of ~10% in the above-gap region of the CdS

and a similar ~10% loss in the CdTe region for the D1.X samples. The two effects may be counterbalancing, but the losses in the CdTe region are more important taking in consideration that carriers generated in the CdS layer typically do not contribute to the photocurrent. (The carrier losses in the CdS layer are related to the fact that the depletion region exists almost entirely in the CdTe layer). Evaluation of the intermixing region shows a more gradual cut-off for the degraded cells. Such behaviour can be linked to a less abrupt junction and higher intermixing between the CdTe and CdS with the inter-diffusion affecting the band gap energies. Although these measurements depict a trend demonstrating changes in the junction quality and CdS region, they should be treated with caution: non uniformity of the individual layers across the whole module is not assured and, furthermore, such effects could be the product of the delamination process.

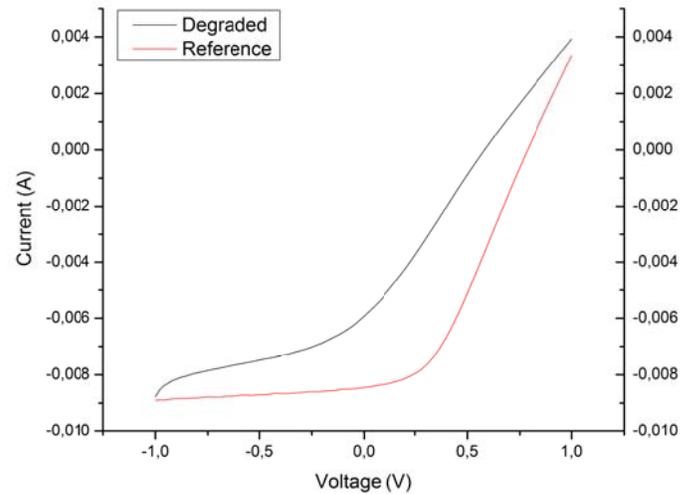
Fig. 5 *I-V* curve calculated from the cells of the degraded and reference module

Similar trends are observed in fig 7 for the *I-V* curves of representative sample groups of the degraded and reference cells. Changes in the series and shunt resistance with a direct impact in *FF* can be seen. Evidence of  $V_{OC}$  reduction is also present on the cell level measurements however, due to the voltage contribution of all cells in a module a wider sample set is needed to confirm the above conclusion. Additionally, non uniformity in the active layers could cause variations in  $I_{SC}$  measurements from the samples.
